Army Lodging Wellness Recommendation

Fort Leonard Wood - Draft Submittal

August 14, 2003

Fort Leonard Wood

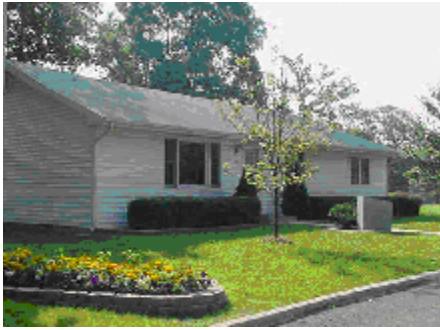
Building 0441

Building 441, constructed in 1990, has one DVQ with a full kitchen. The facility is in good condition but does not meet current Army Lodging standards. The cost to renovate this building to the new Lodging standards and configuration will exceed the 50% replacement cost.

Building 441 was constructed in 1990. The 1,339 square foot facility contains a family suite with a full kitchen. The building is functioning as a family suite.

Our recommendation is to remove building 441 from the Lodging inventory, allowing the installation to determine an alternate use for this facility. This facility will be removed from the Fort Leonard Wood Wellness Solution and Lodging Master Plan.

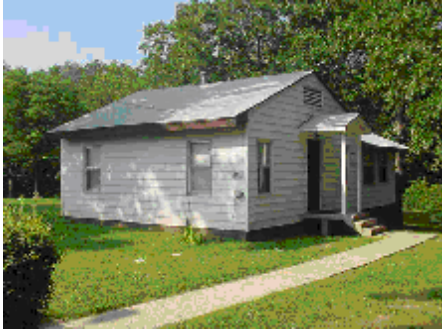
Building 0443

Building 443 was constructed in 1941. The 1,331 square foot facility contains a family suite with a full kitchen. The building is functioning as a family suite.

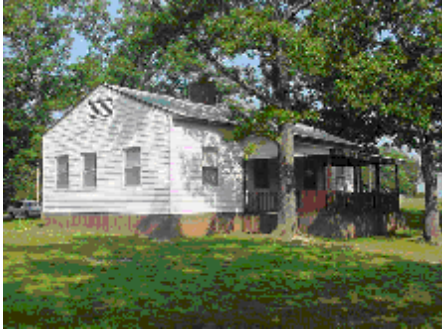
Building 0444

Building 444 was constructed in 1941. The 1,056 square foot facility contains 1 lodging unit operating as 1 family suite.

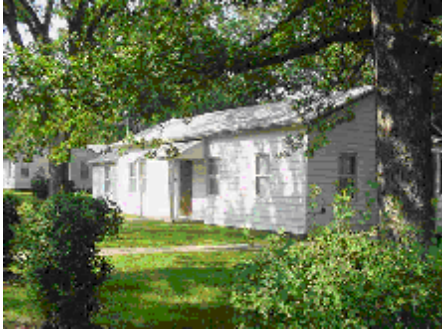
Building 0446

Building 446 was constructed in 1941. The 1,970 square foot facility contains 1 lodging units operating as 1 family suite.

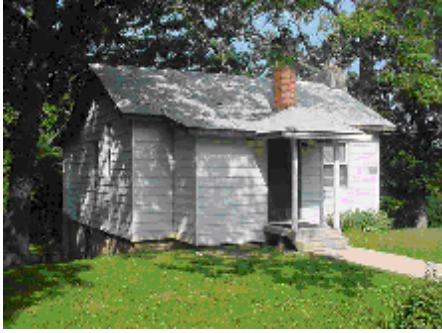
Building 0448

Building 448 was constructed in 1941. The 1,004 square foot facility contains a family suite with a full kitchen. The building is functioning as a family suite.

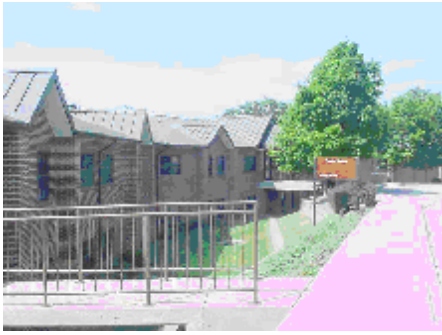
Building 2030 was constructed in 1992. The 42,526 square foot facility contains 70 lodging rooms functioning as 70 family suites.

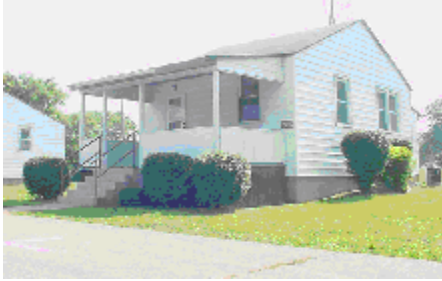
Building 2040 is a single-story wood-framed buildings constructed in 1941. It is about 700 square feet in size, and contains one family suite with a full kitchen.

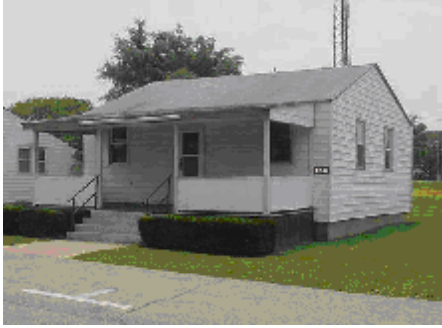
Building 2041 is a single-story wood-framed buildings constructed in 1941. It is about 800 square feet in size, and contains one family suite with a full kitchen.

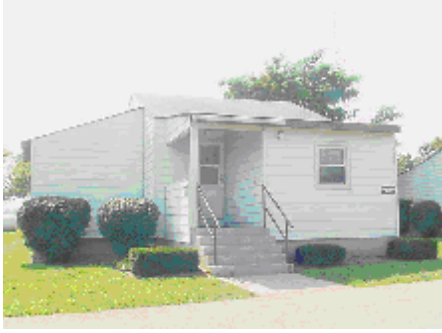
Building 2042 is a single-story wood-framed buildings constructed in 1941. It is about 850 square feet in size, and contains one family suite with a full kitchen.

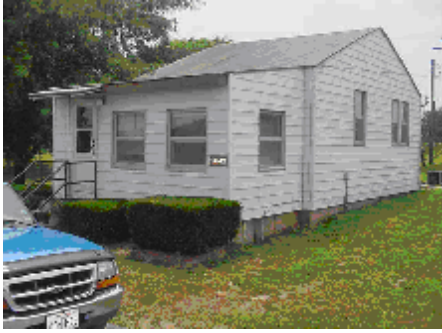
Building 2043 is a single-story wood-framed buildings constructed in 1941. It is about 700 square feet in size, and contains one family suite with a full kitchen.

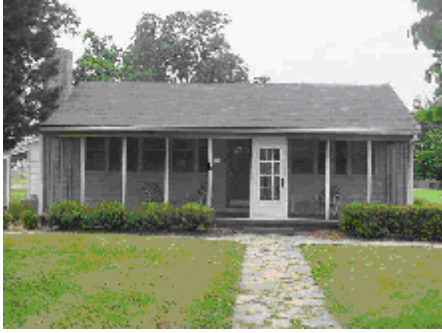
Building 2051

Building 2051, constructed in 1941, is a single story structure housing one DVQ suite with full kitchen. The facility is in good condition but does not meet current Army Lodging standards. The cost to renovate this building to the new standards and configuration will exceed the 50% replacement cost.

Building 2051, constructed in 1941, has one DVQ suite with a full kitchen at 1,200 square feet. The building has vinyl siding and a sloped shingled roof and is one story without a basement.

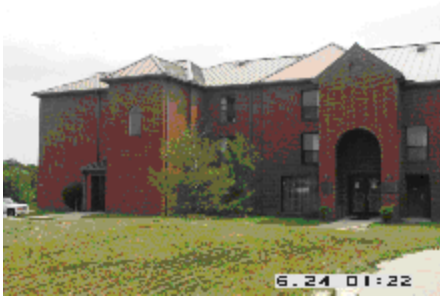
Fort Leonard Wood, MO, Building 3214

Building 3214 was constructed in 1989. The 43,242 square foot facility contains 87 lodging units operating as 81 extended stay rooms and 6 family suites.

Our recommendation is to retain Buildings 3211, 3212, 3213, and 3214 in the Fort Leonard Wood Lodging inventory. These facilities will remain in the Fort Leonard Wood Wellness Solution and Lodging Master Plan.

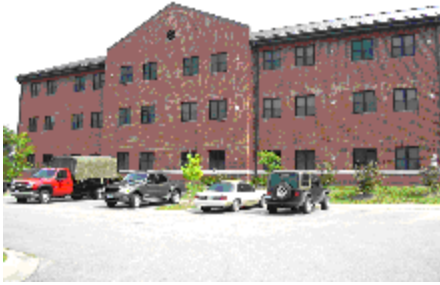
Frontal view of Building 3231, Fort Leonard Wood, MO.

Building 3231, 230 Gate Street, Ft. Leonard Wood, MO. 65473, is a three-story brick building built in 1999. The 22,822 SF facility consists of 36 two person modules with 2 private bedrooms and a shared bathroom and kitchen with refrigerator, microwave and sink. The facility functions as 72 extended stay rooms for students.

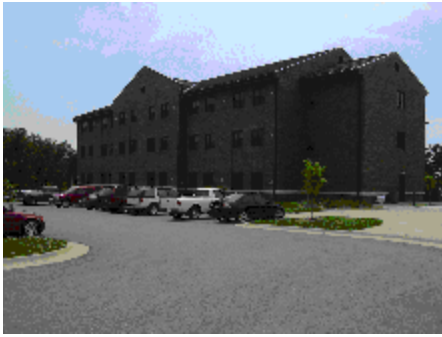
Building 3232

Building 3232, 230 Gate Street, Ft. Leonard Wood, MO. 65473, is a three-story brick building built in 1999. The 22,822 SF facility consists of 36 two-person modules with 2 private bedrooms and a shared bathroom and kitchen with refrigerator, microwave and sink. The facility functions as 72 extended stay rooms for students.

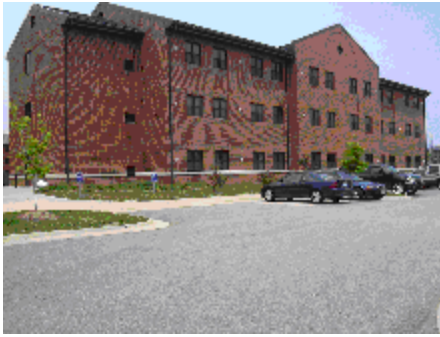
Building 3233

Building 3233, 230 Gate Street, Ft. Leonard Wood, MO. 65473 is a three-story brick building built in 1999. The 31923 SF facility consists of 48 two-person modules with 2 private bedrooms and a shared bathroom and kitchen with refrigerator, microwave and sink. The facility functions as 96 extended stay rooms for students.

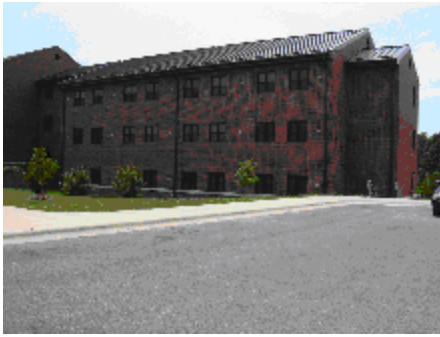
Building 3234

Building 3234, 230 Gate Street, Ft. Leonard Wood, MO. 65473, is a three-story brick building built in 1999. The 22,822 SF facility consists of 36 two-person modules with 2 private bedrooms and a shared bathroom and kitchen with refrigerator, microwave and sink. The facility functions as 72 extended stay rooms for students.

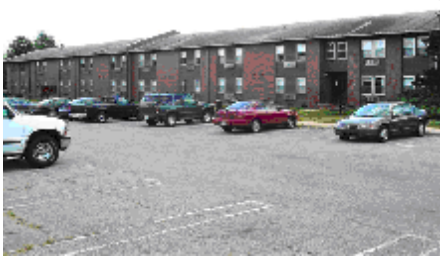
*Ft. Leonard Wood, MO., Building 4101,
Exterior View*

Building 4101 is part of a complex of five similar brick buildings constructed in 1965 and 1966. All are two stories high with a basement boiler room. Building 4101 has 32 extended stay units with a full kitchen and 8 family suites with a full kitchen.
